HUNTINGTON BEACH POLICE DEPARTMENT
CASUALTY REPORT

Code Offense Description
- DEATH REPORT
Date Occurred: SUN 02/25/96 at 19:30
Or Between: SUN 02/25/96 at 20:10
Discovered: SUN 02/25/96 at 20:10
Reported: SUN 02/25/96 at 20:10

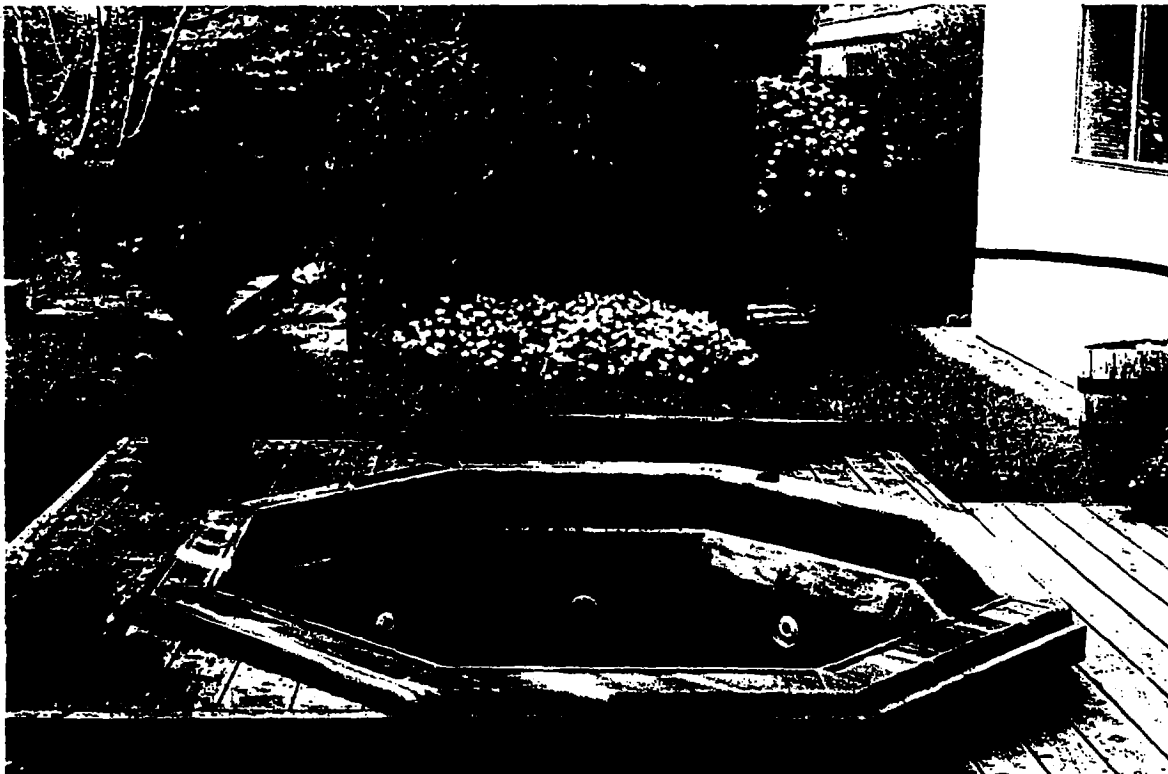
#2, SPA IN WOODEN DECK. "A" IS FENCE AROUND
EQUIPMENT AREA.

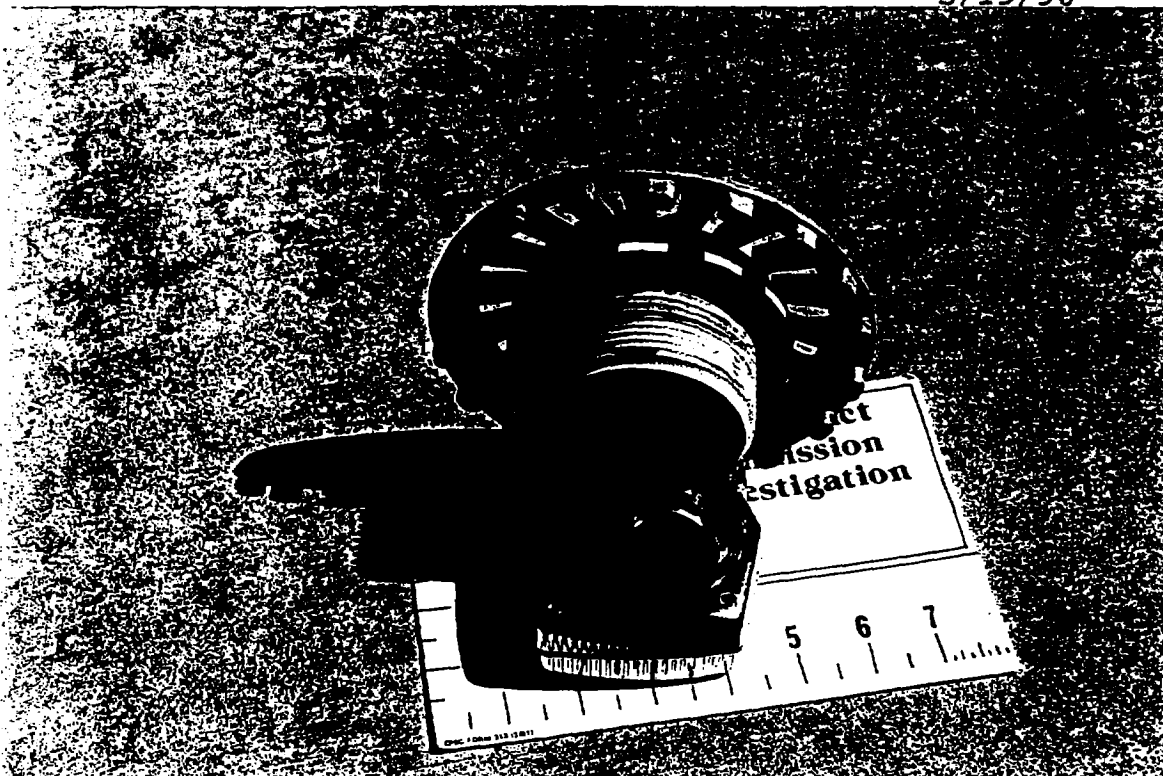
#17 SECTION COVER, SIDE.

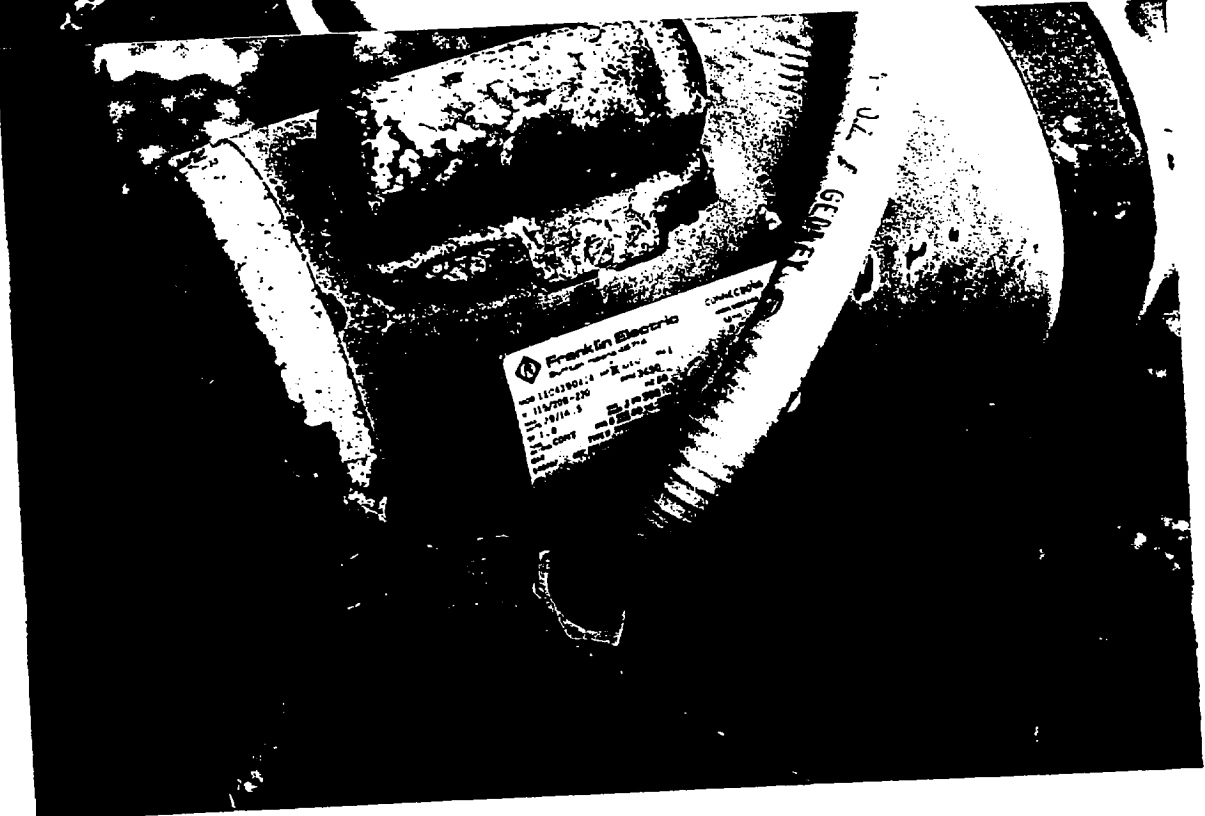
#24, Jet motor.
